**USAARL Report No. 2002-13**

Evaluation of Pinch Correction in the Phase 2 Microvision, Inc. Aircrew Integrated Helmet System HGU-56/P Scanning Laser Display

**July 2002**

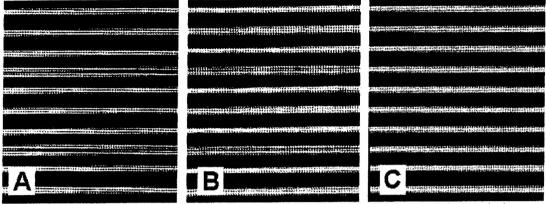
If pinch correction is effective, all line pairs should have the same photographic thickness. Figure 4 shows images captured from the left edge of the left channel. The photograph in Figure 4A was taken with pinch correction off. Note that every fourth pair of lines was thicker than the others. As this pattern did not agree with our prediction of the non-pinch corrected pattern, calibration patterns were examined for inconsistencies. Unfortunately, none were found. After further investigation, we discovered a small piece of black tape stuck to the scanner housing. The tape had torqued the scanner housing. Removing the tape and recalibrating solved the problem. Figure 4B shows the proper non-pinch corrected pattern consisting of alternating thick and thin line pairs. Figure 4C shows a good example of properly aligned optics coupled with pinch correction. Note the uniform thickness of the horizontal line pairs.

Figure 4. Photographic images of line pairs near the left edge of the left side display. (A) Non-pinch corrected condition coupled with a torqued scanner housing (see text for explanation). (B)

Typical non-pinch corrected pattern consisting of alternation thick and thin line pairs. (C) Pinch-corrected condition with proper calibration and alignment.

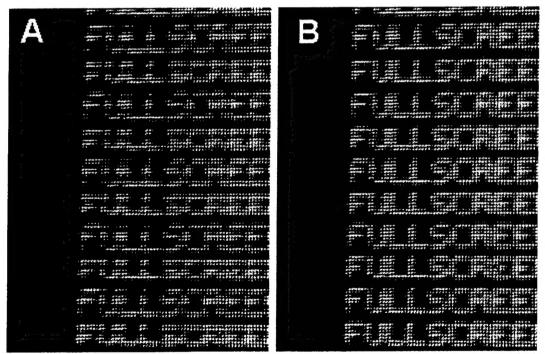
To view the effects of pinch correction in another way, 5 by 5 text characters were displayed near the lateral periphery. Figure 5 shows photographic images captured under the two conditions. Letter fragmentation or gaps are seen in the uncorrected condition, whereas the pinch-corrected condition shows fairly good character definition

Figure 5. Photographic images of 5 by 5 text characters. (A) Non-pinch corrected text imagery. (B) Pinch corrected text imagery.

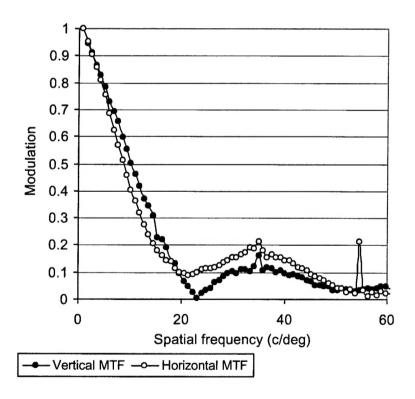
The vertical MTF has a modulation of about 0.23 modulation at the Nyquist frequency, (approximately 15.6 cycles/degree) and the horizontal MTF has a modulation of about 0.17 at the same frequency. These MTFs show slight improvement over the MTFs measured last (Harding et al., 2001b).

Figure 6. MTFs measured from the left side of the HMD.
